State of Utah DEPARTMENT OF NATURAL RESOURCES Division of Oil, Gas & Mining

Inspection Report

Minerals Regulatory Program
Date of Report: June 10, 2008

Operator Name: Quality Building Stone	Inspection Date: May 12, 2008 Time: 3:30-4:30 PM Weather: Cloudy, 30s, showers, very windy		
Inspector(s): Paul Baker Other Participants: None Mine Status: Active			
Elements of Inspection	Evaluated	Comment	Enforcement
 Permits, Revisions, Transfer, Bonds Public Safety (shafts, adits, trash, signs, highwalls) Protection of Drainages / Erosion Control Deleterious Material Roads (maintenance, surfacing, dust control, safety) Concurrent Reclamation 			
 7. Backfilling/Grading (trenches, pits, roads, highwalls, shafts, drill holes) 8. Water Impoundments 9. Soils 10. Revegetation 			
11. Air Quality12. Other

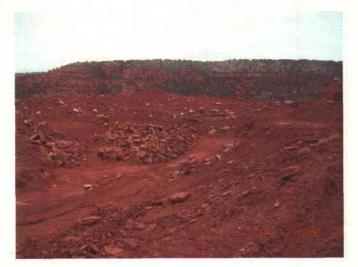
Photo 1. This is the main quarry area.

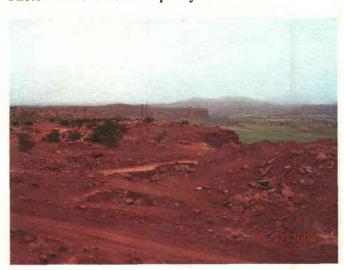
Photo 2. The east side of the main quarry.

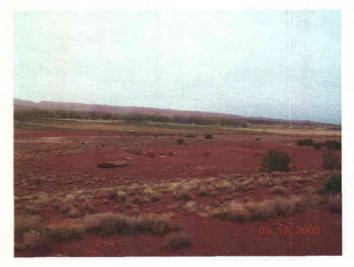
This mine site was originally determined to be larger than five acres, but the operator consolidated and removed much of the equipment and materials in an attempt to reduce the size. It does not appear these areas from which items were removed are being used, but there is little or no vegetation in them.

Photo 3. An area formerly used to store and load rocks.

The operator should try (or re-try) to establish vegetation in the areas that were formerly used to store and load rocks.

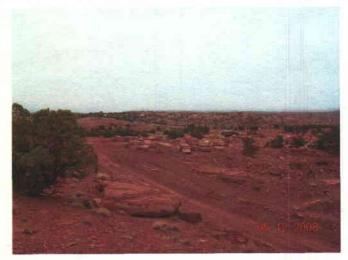
I did not try to measure the size of loading areas, but they appeared to be in the range of about one-half acre.

Photo 4. This shows part of the area now being used for storage and loading.
